BCT Meeting

Remedial Action Update Parcel B (Excluding IR Sites 7 & 18)

August 29, 2013

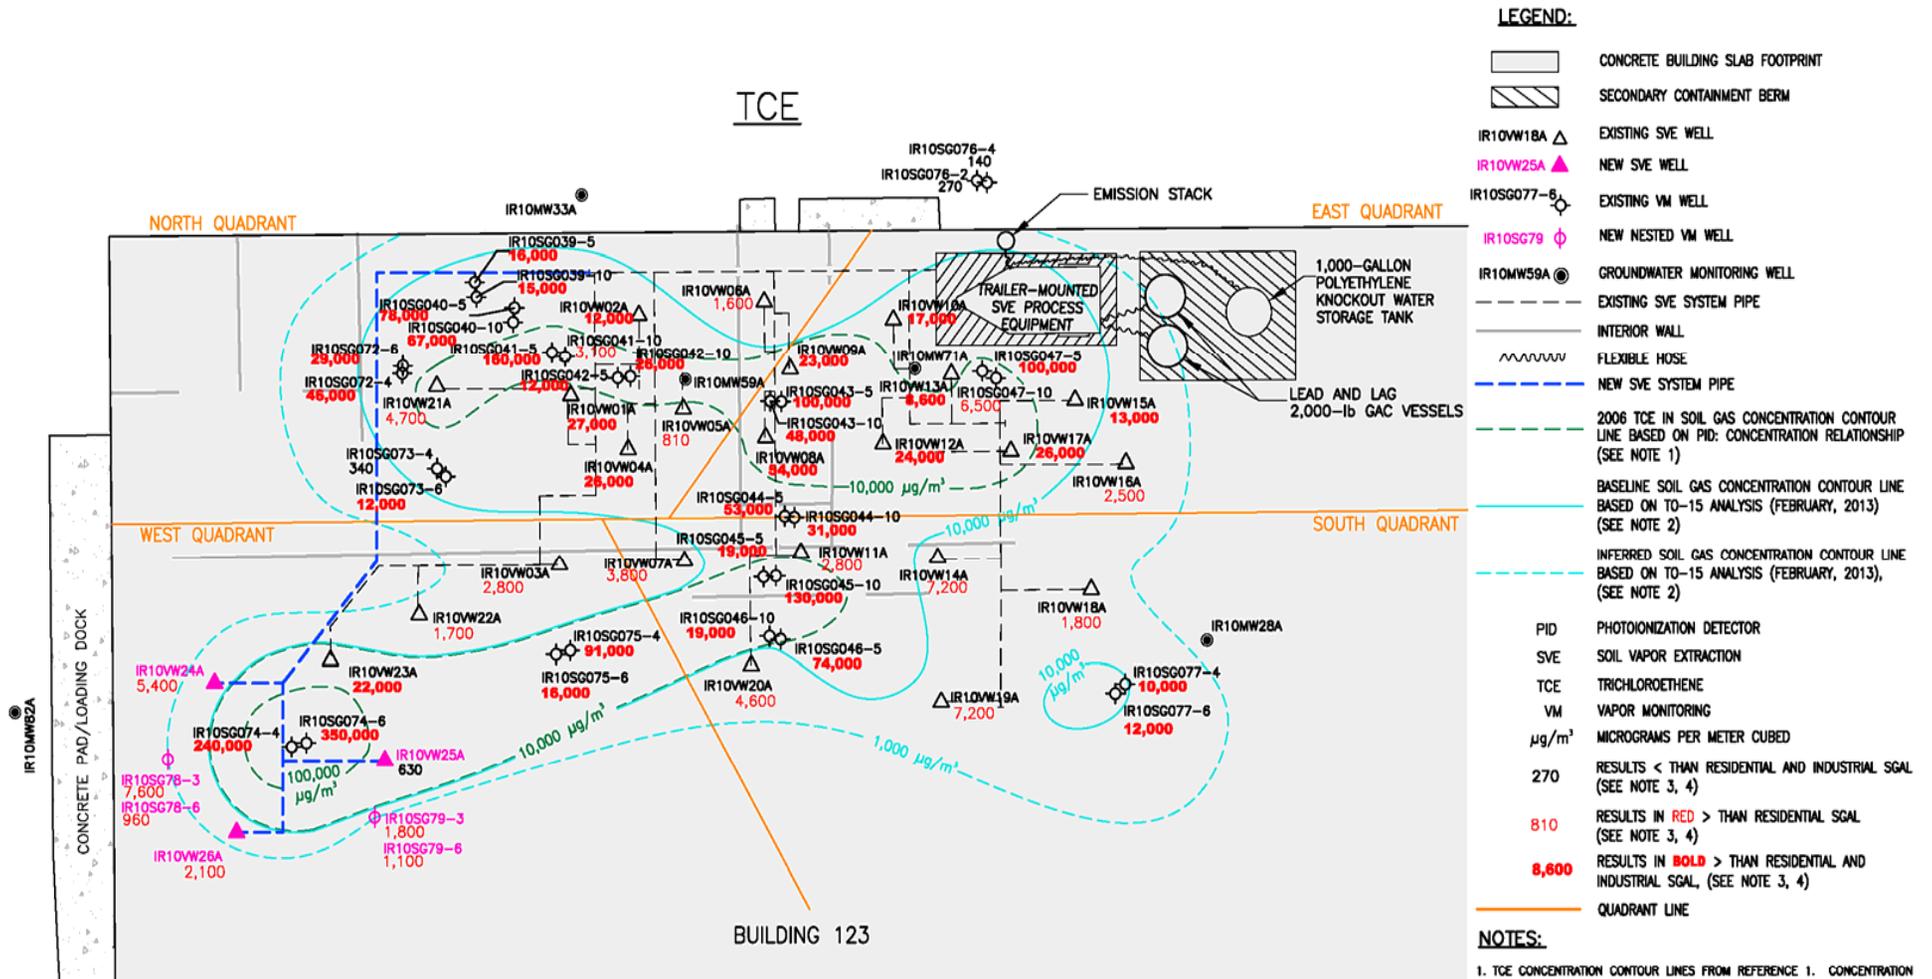
Review: SVE System by Quadrants

- Divided the VOC plume into four quadrants based on baseline data
- Collected data during system startup from each quadrant to evaluate localized SVE effects (e.g., vacuum-to-flow relationship, flow-to-concentration relationship, ROI)
- Strategy allowed for expanding data collection beyond limits of quadrants
- Performing cycling (rotation) of SVE wells between the quadrants (to maximize and focus treatment by area and allow adequate time for rebound/ recovery in each area)

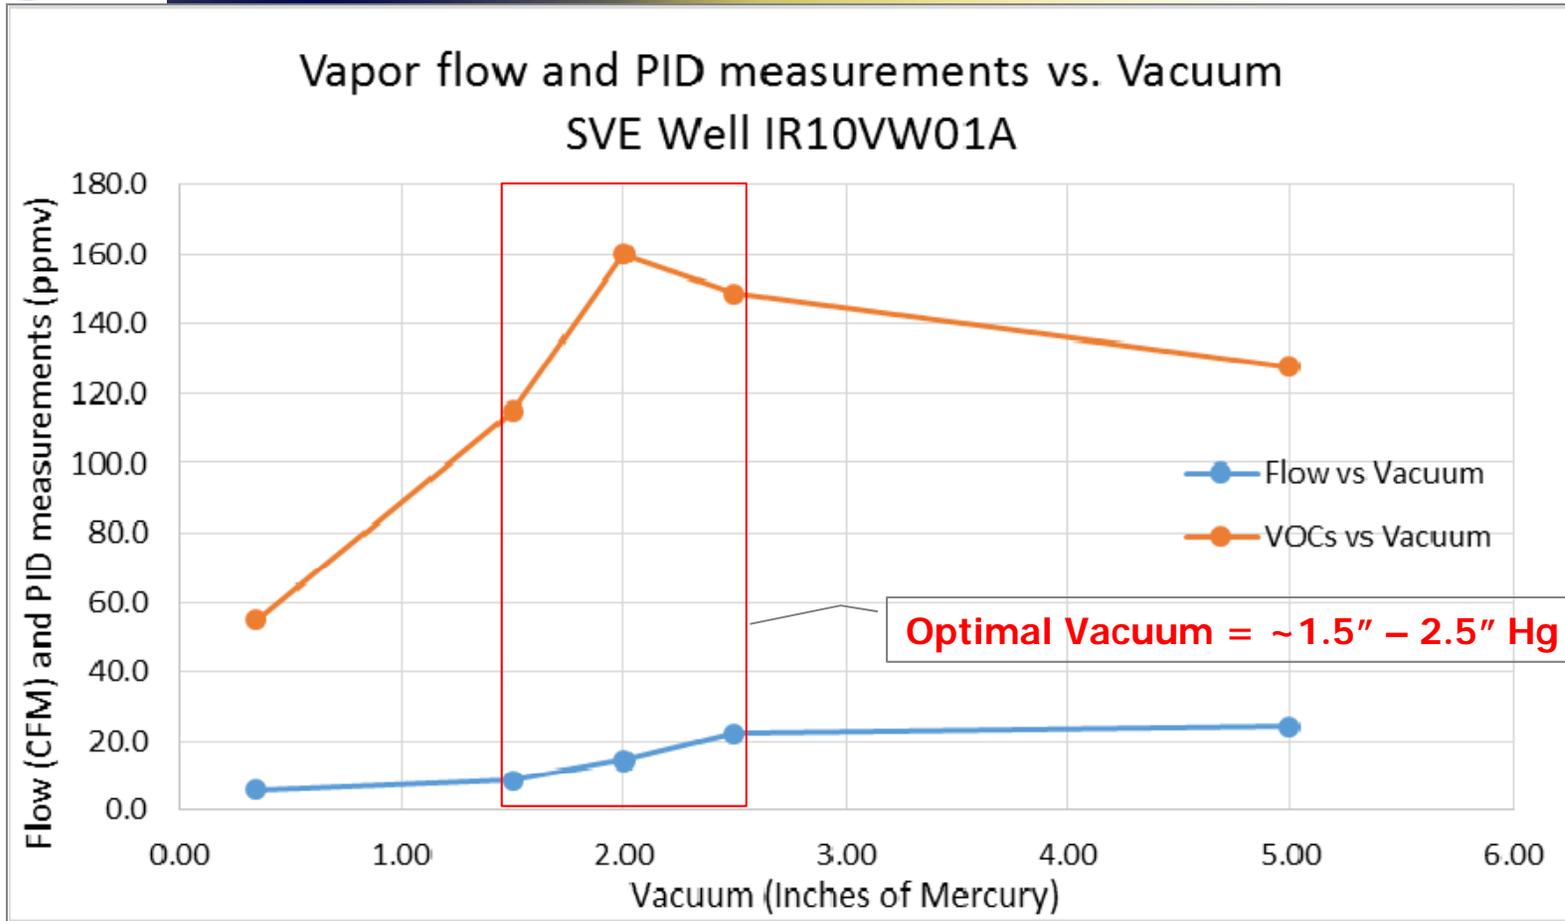
Example Step Test Data Evaluation SVE Well VW01A (North Quadrant)

1. Blower temperature spike, with extremely turbulent SVE flow above 5.0 "-Hg.
2. Target applied vacuum range: 1.5 – 2.5" Hg

- Operated each well at approximately 25, 50, 75, and 100% of maximum vacuum (Test 1) and measured vacuum pressure, vapor flow rate, and relative presence of VOCs (using PID readings)
- Plotted vapor flow rate and relative PID reading vs. applied vacuum to determine optimal operating range (i.e., target vacuum pressure for each well)
- Example step test result for an SVE well on next slide

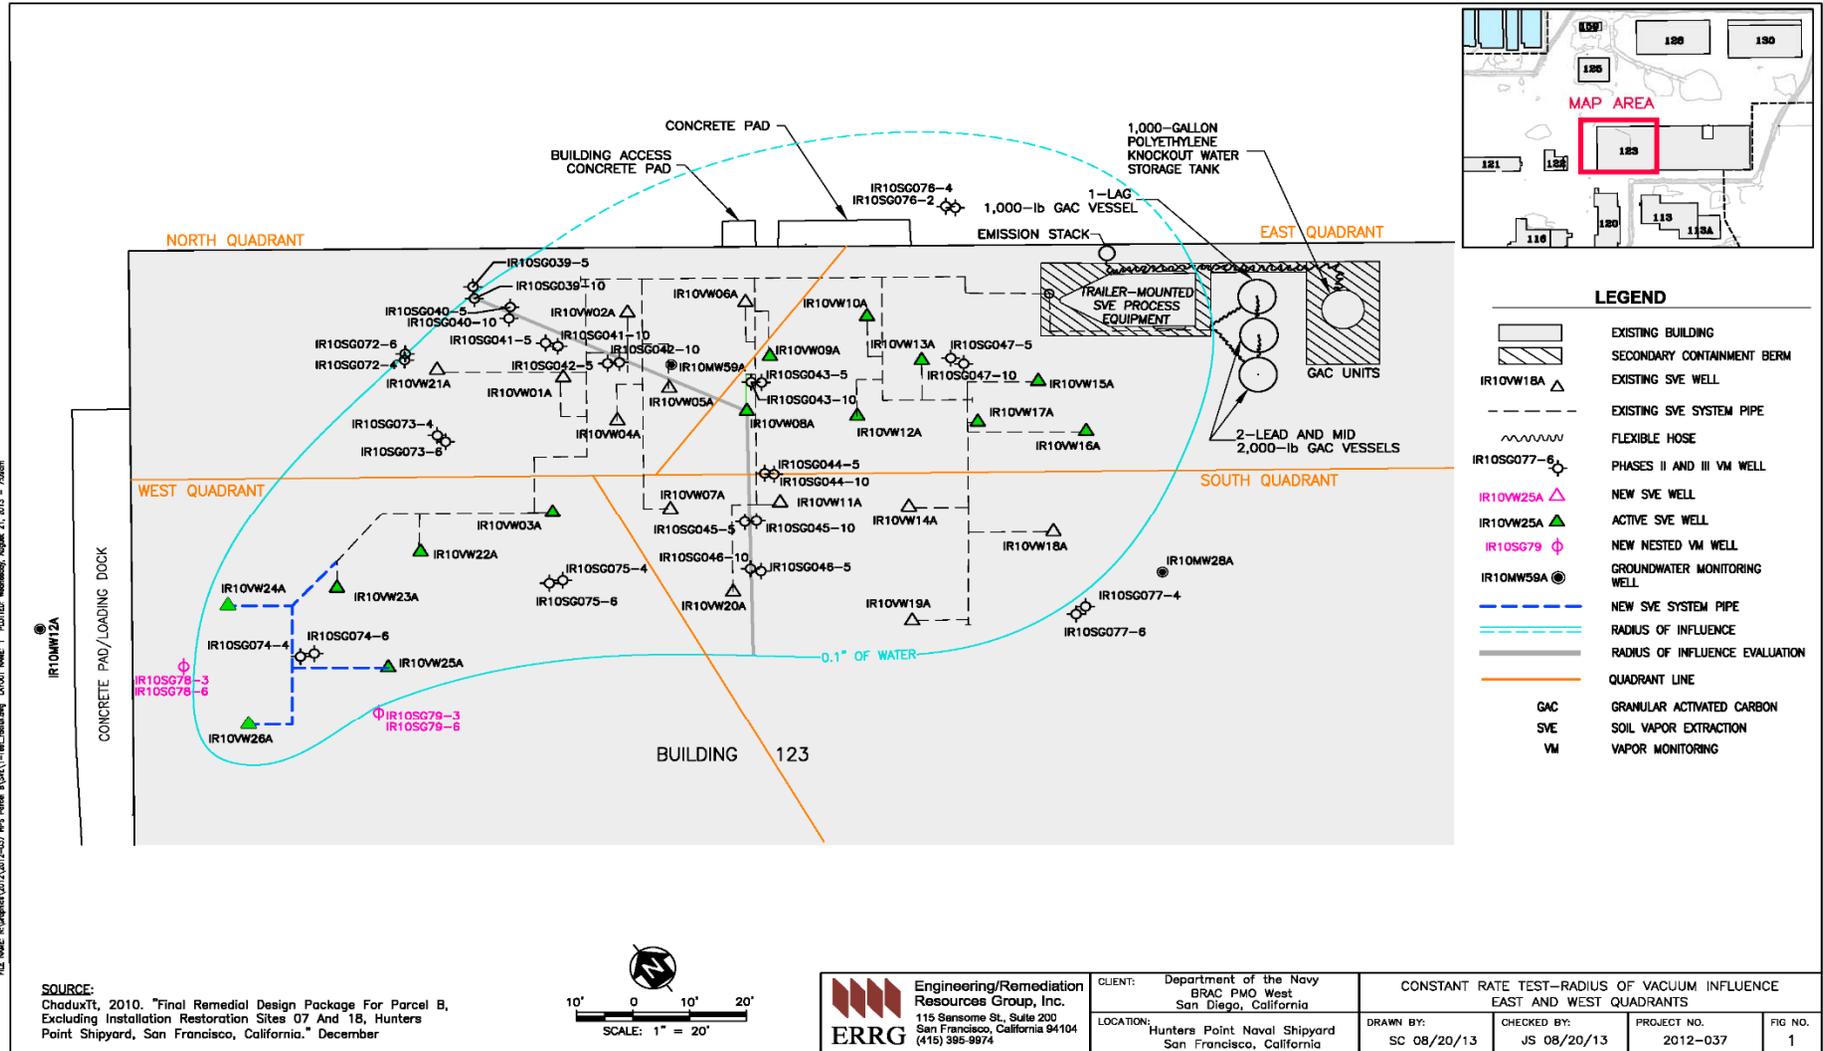
ROI Estimated by Constant Rate Test East and West Quadrants

- Operated SVE wells in East and West quadrants simultaneously for first constant rate test (based on results of Test 3)
- System operated for 13 consecutive days
- Measured ROI (defined as vacuum to 0.1" of H₂O) following stabilization of multi-well flow field
- Performed periodic TO-15 sampling and PID monitoring of SVE system granular activated carbon (GAC) vessels influent, midstream, and effluent to evaluate mass removal, treatment efficiency, and ensure compliance with BAAQMD discharge requirements
- Currently performing constant rate test in North and South quadrants simultaneously. Based on preliminary results, expanded well flow field to include a portion of the West quadrant.

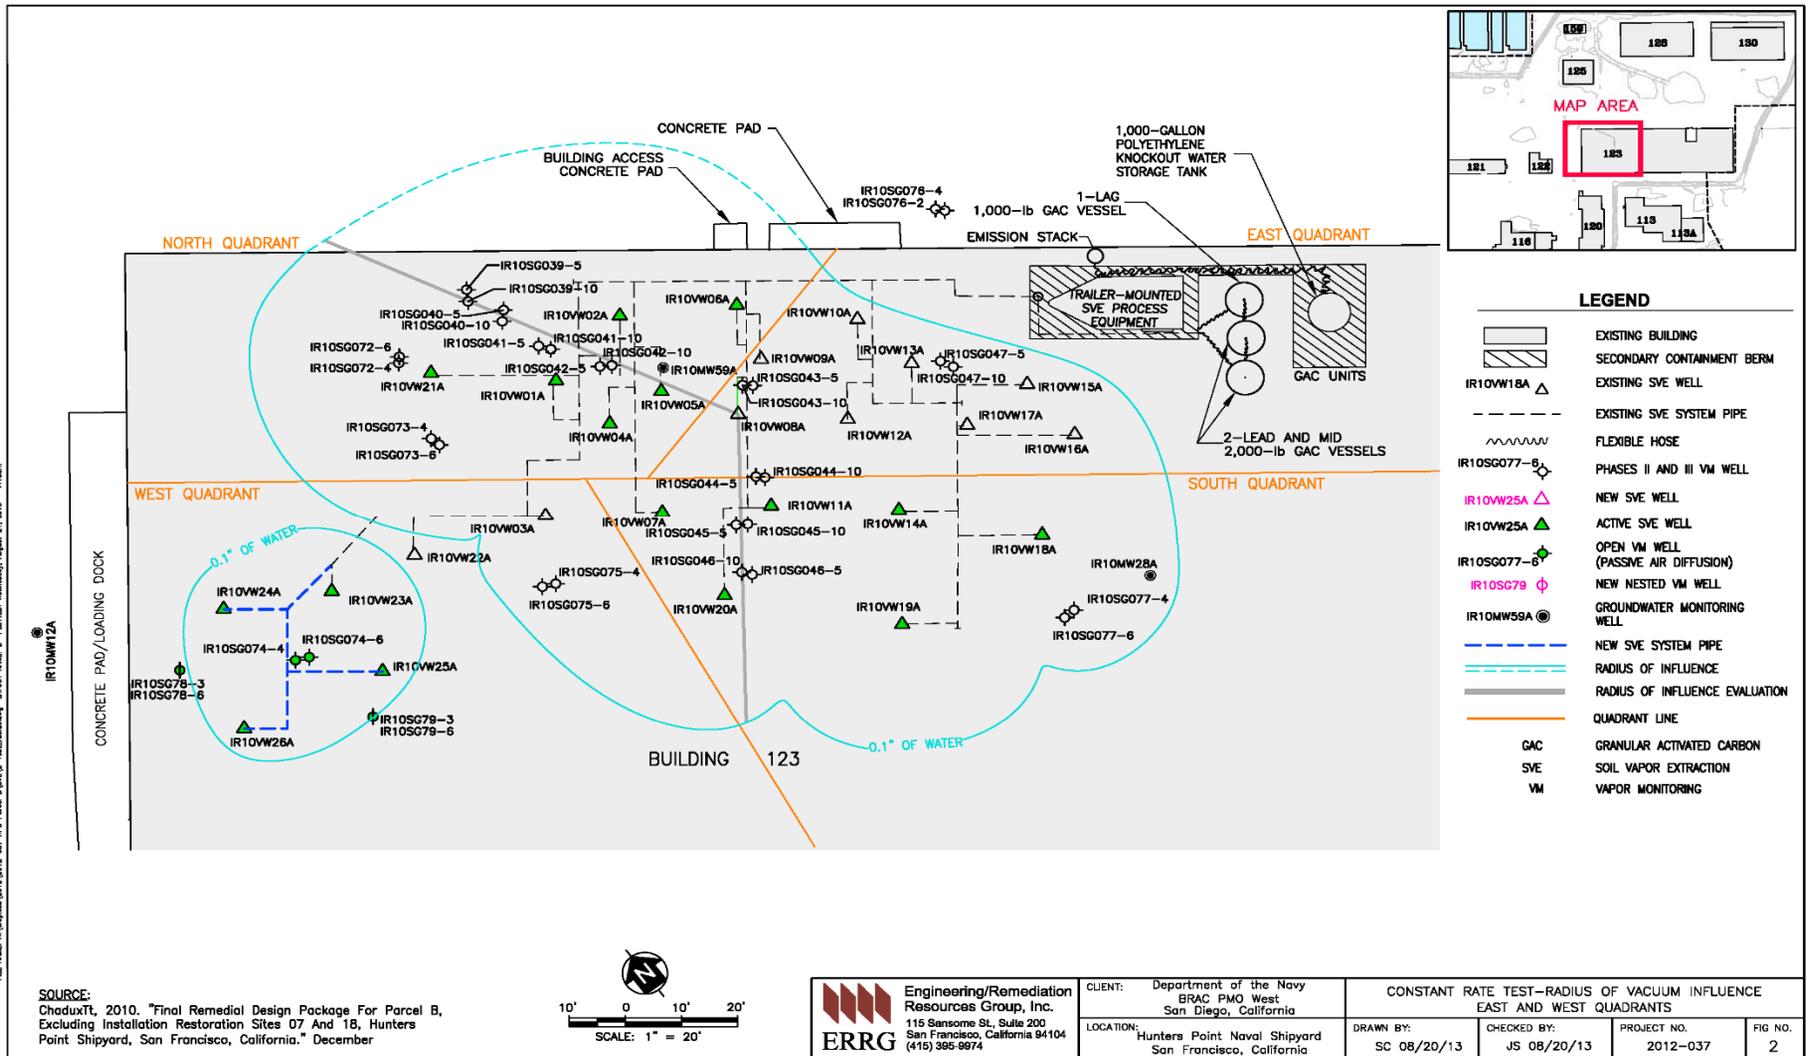
ROI Estimated by Constant Rate Test North, South, and West Quadrants

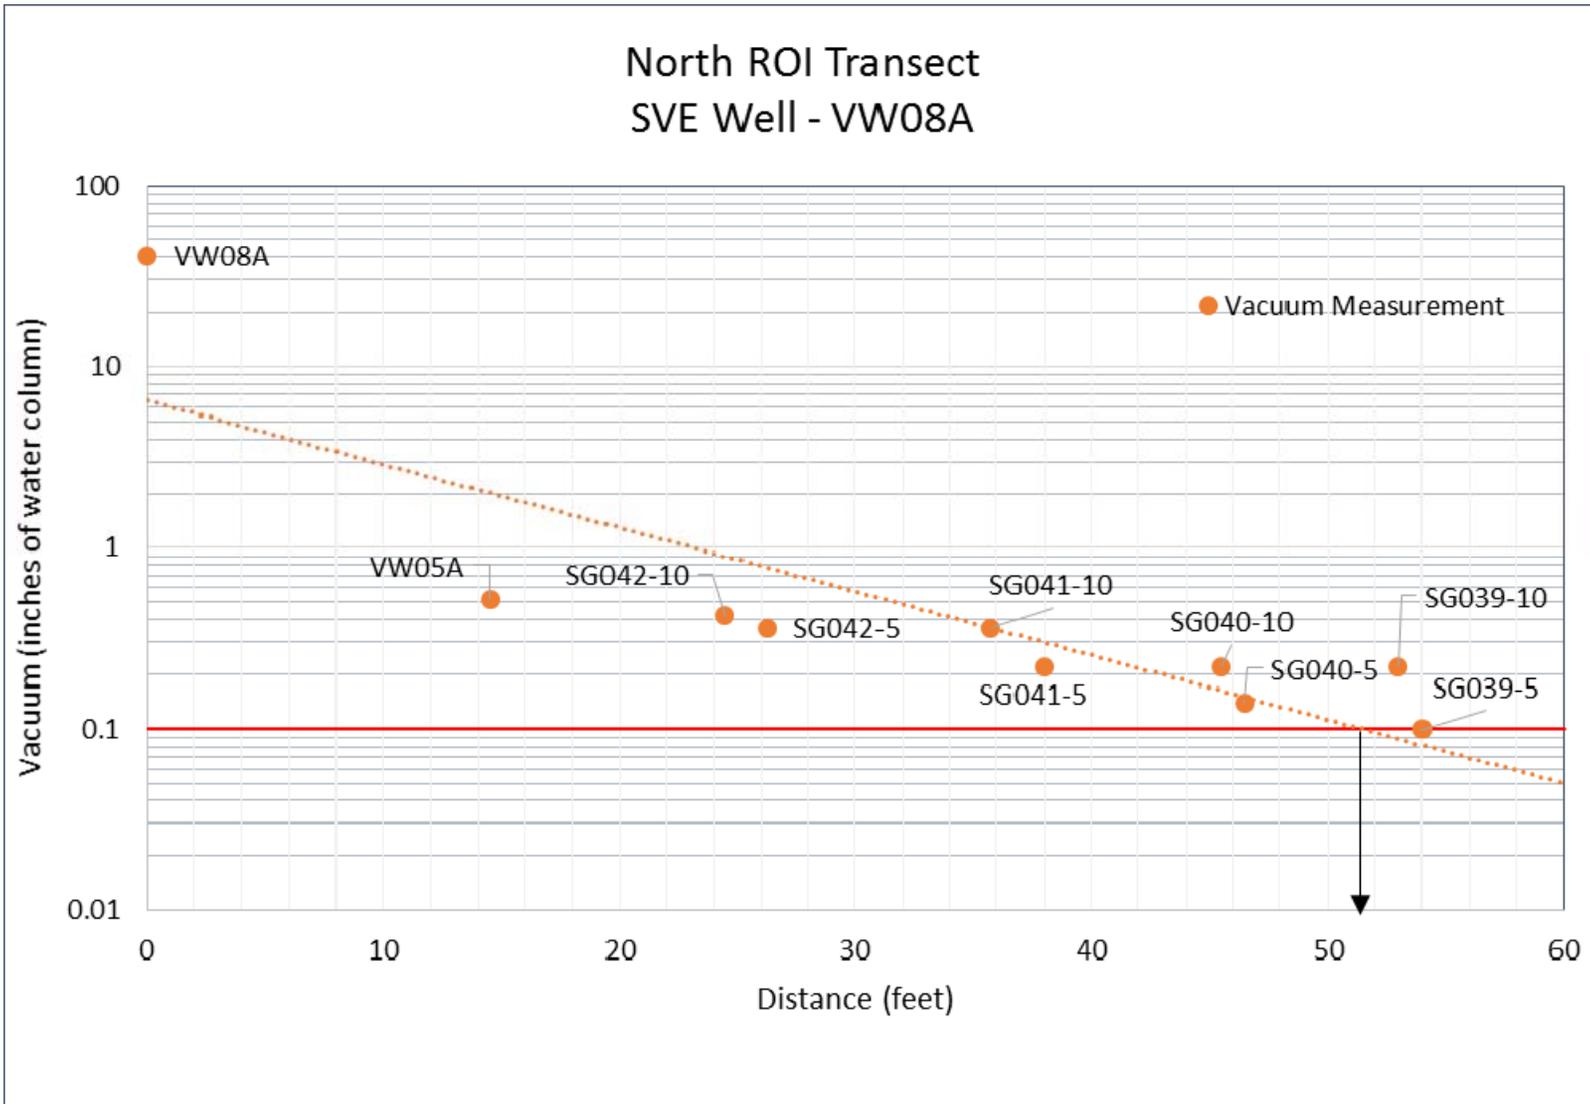
Constant Rate Test East and West Quadrants

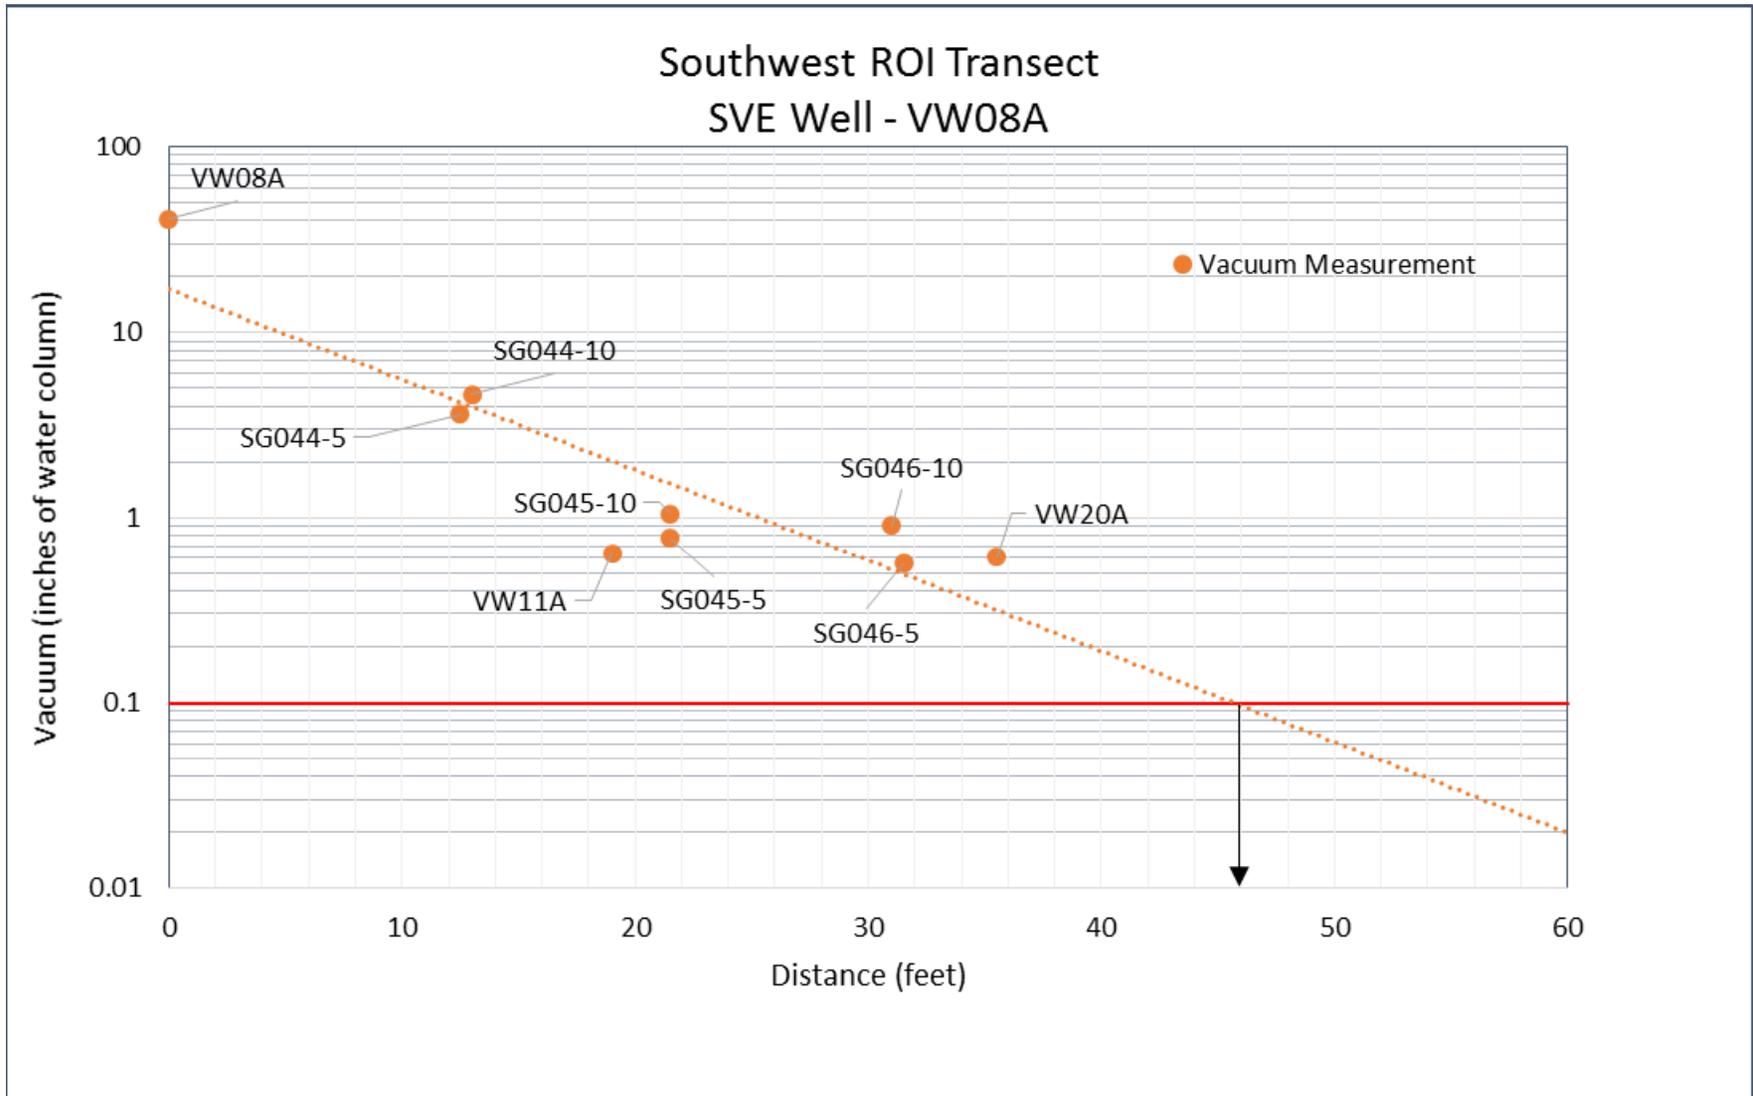
Constant Rate Test East and West Quadrants

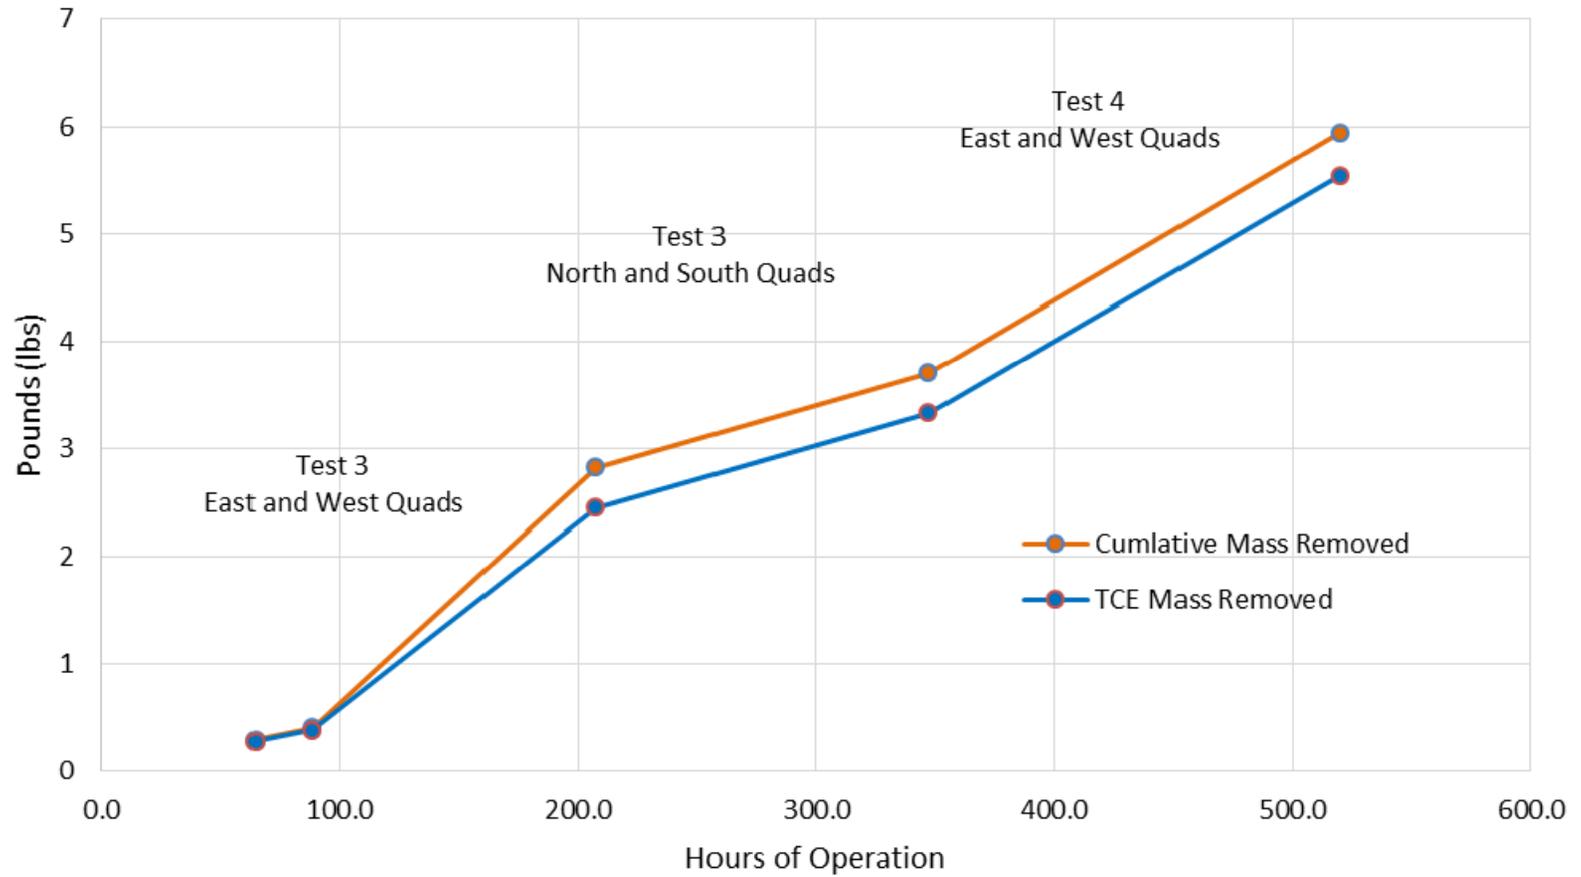
Cumulative Mass Removed Total VOCs and TCE by TO-15 Analysis

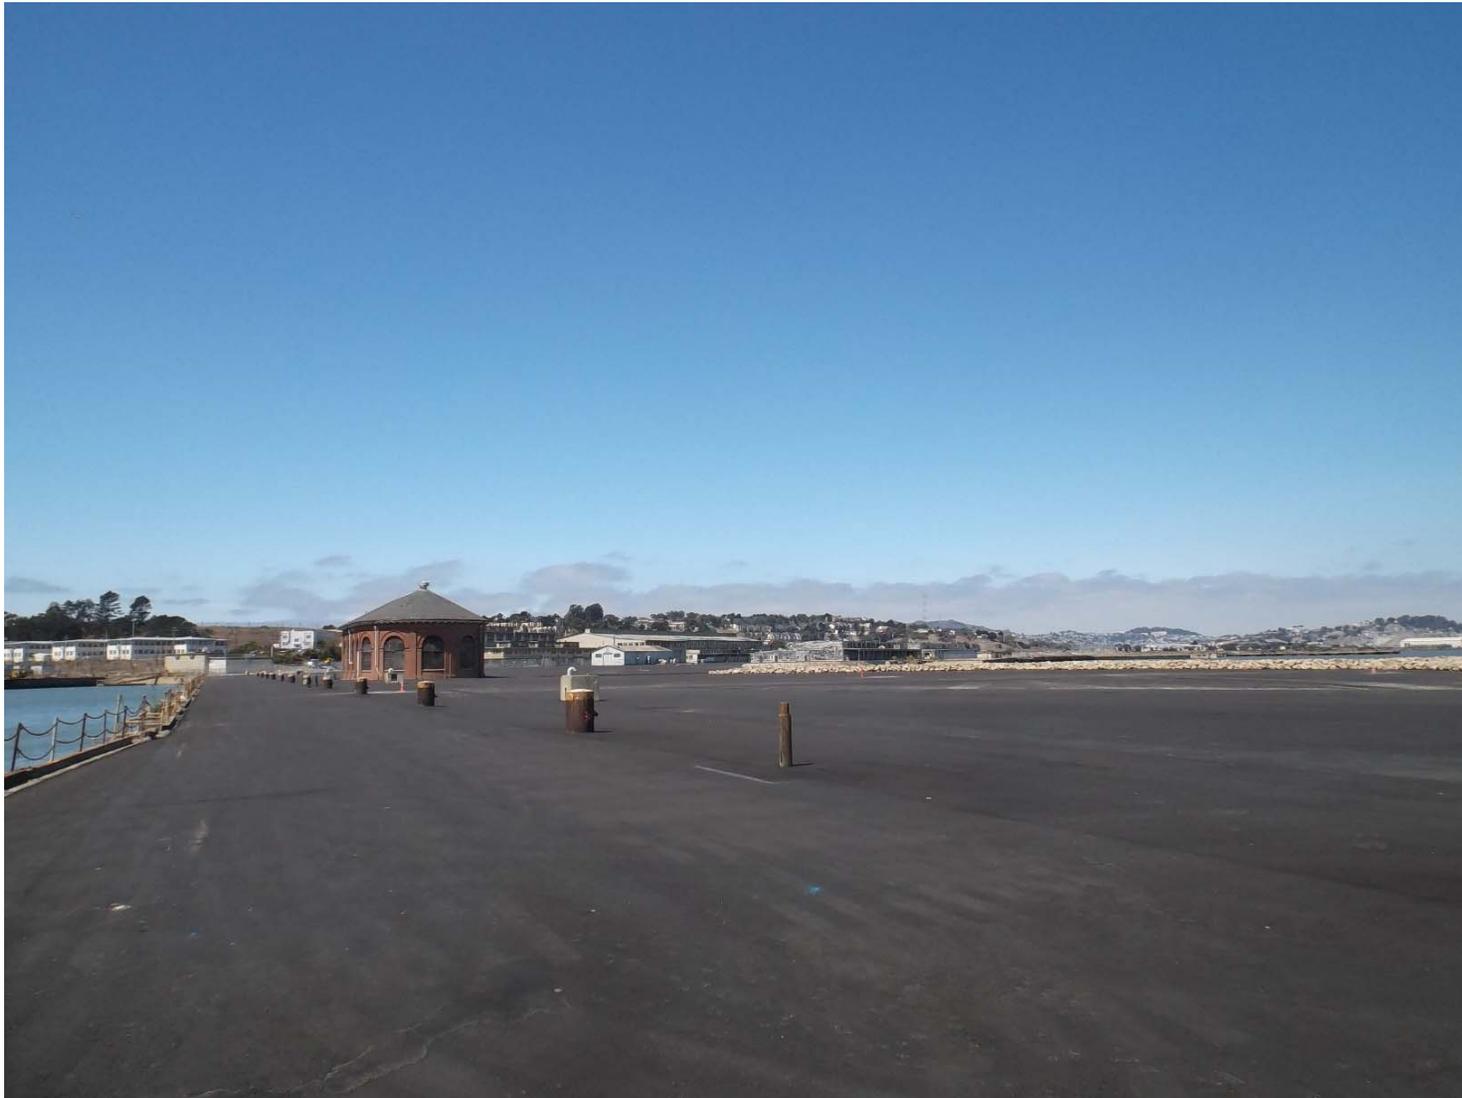
Asphalt Cover Installed Near Dry Dock 3/Building 140

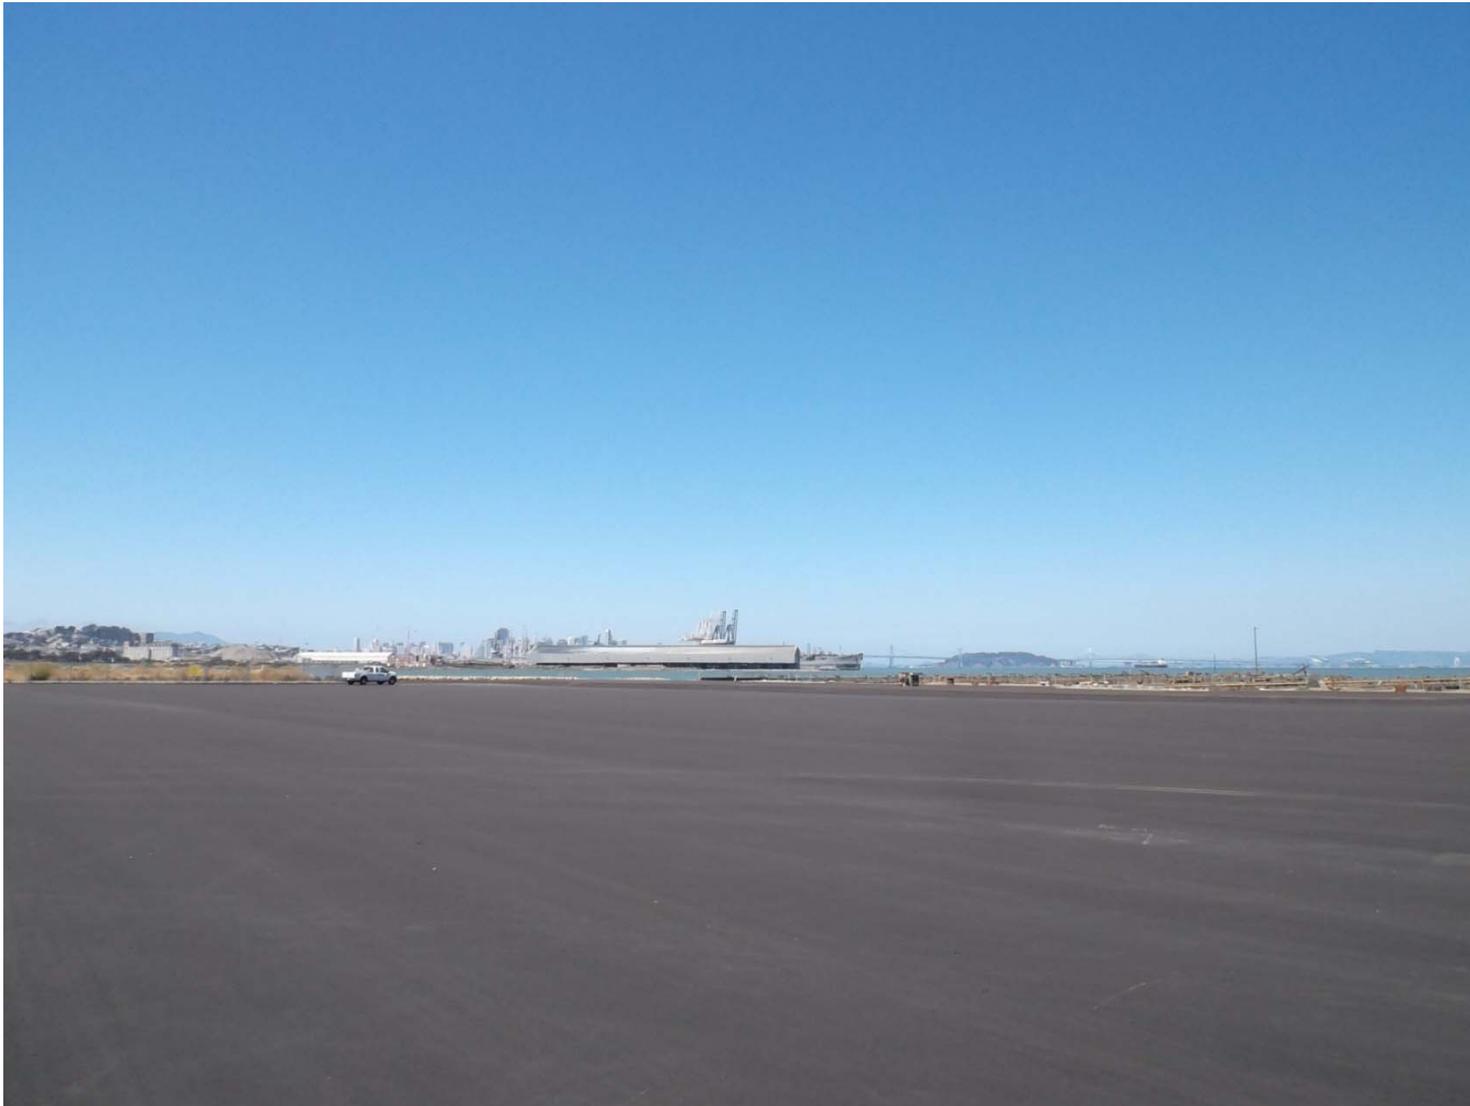
Asphalt Cover Installed Near Sub Pens and 7/18

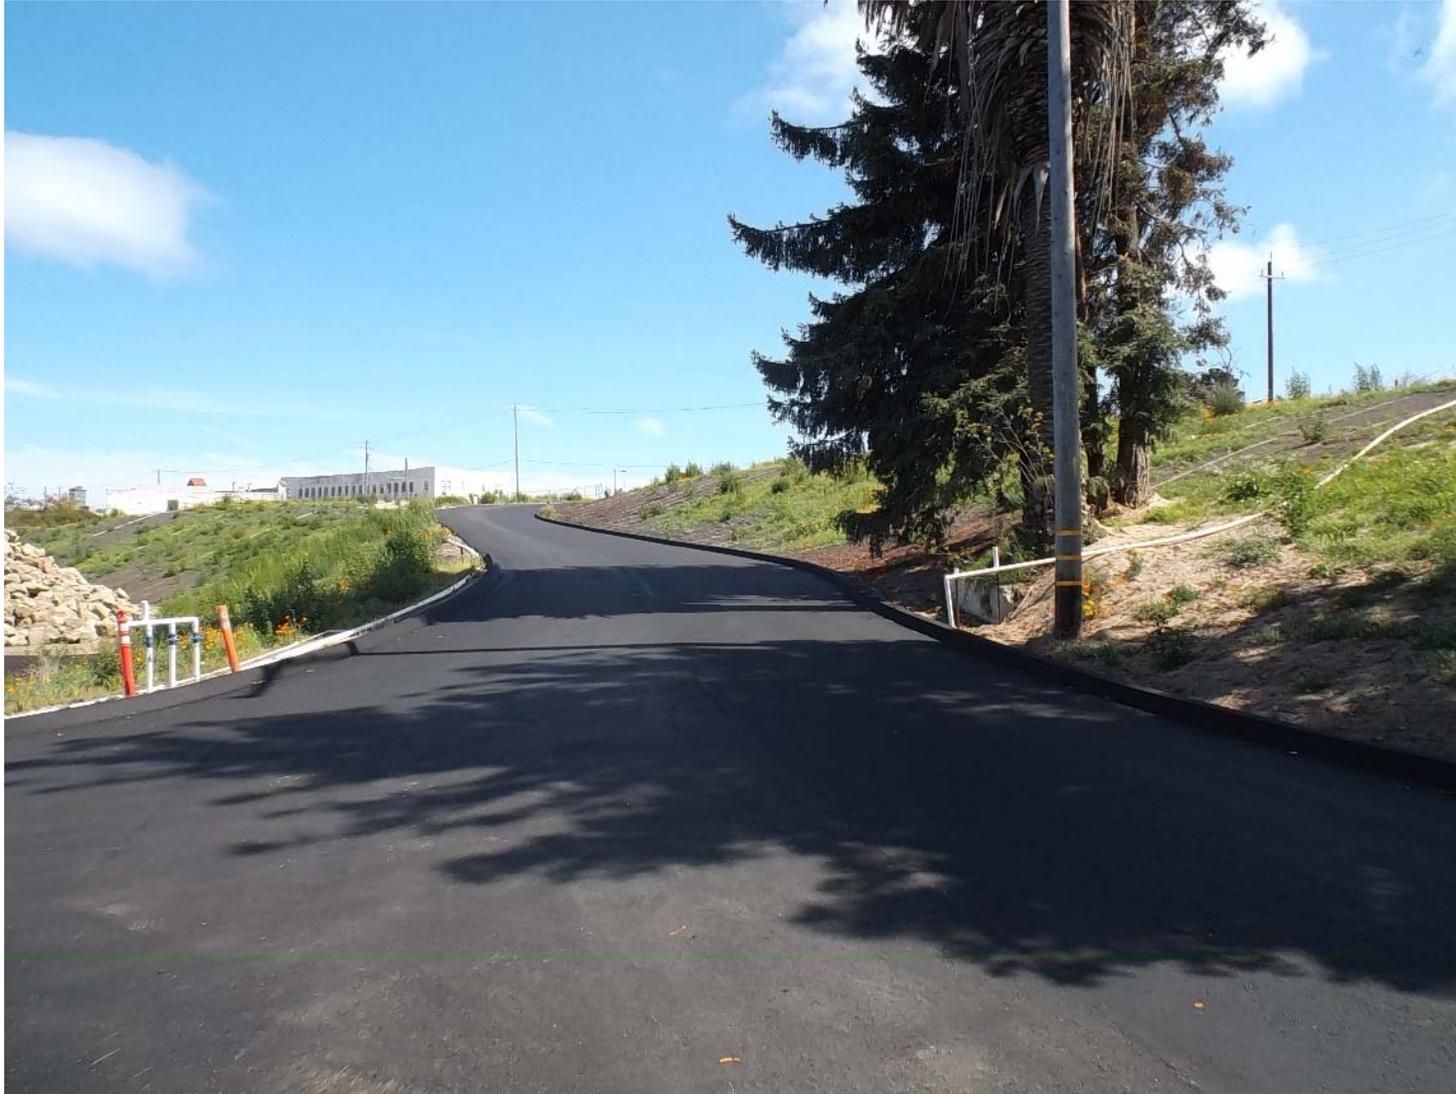
McCann Street Paved and New Curbs Installed

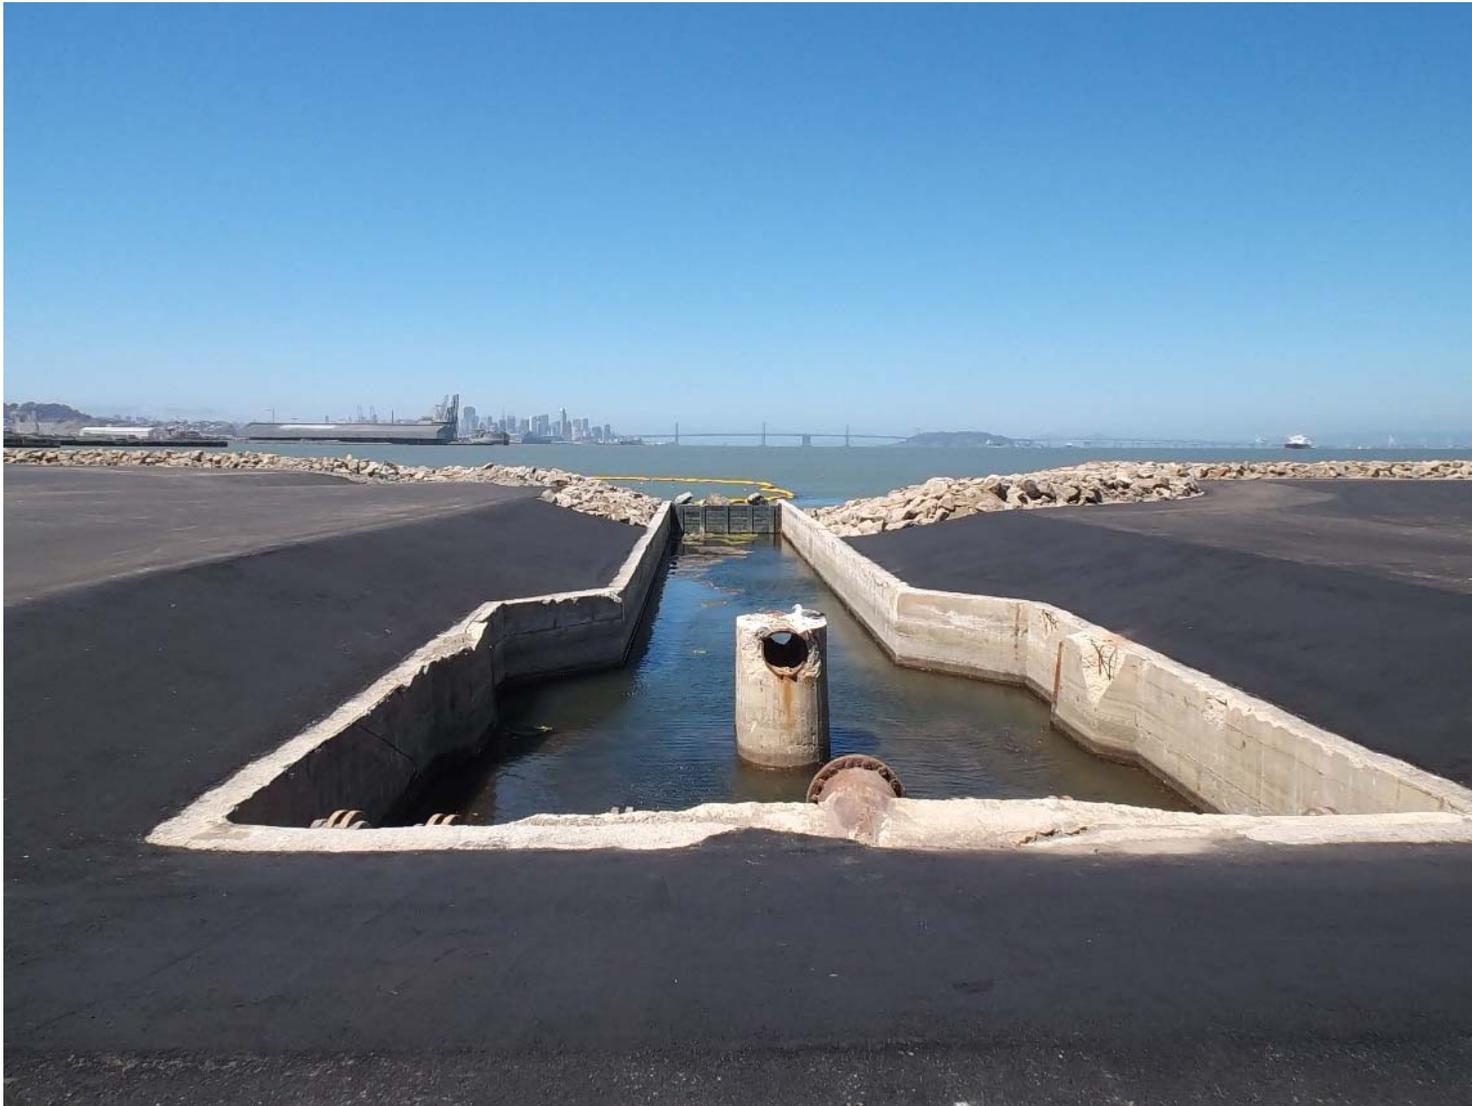
Asphalt Cover Installed Around Pump House Outfall

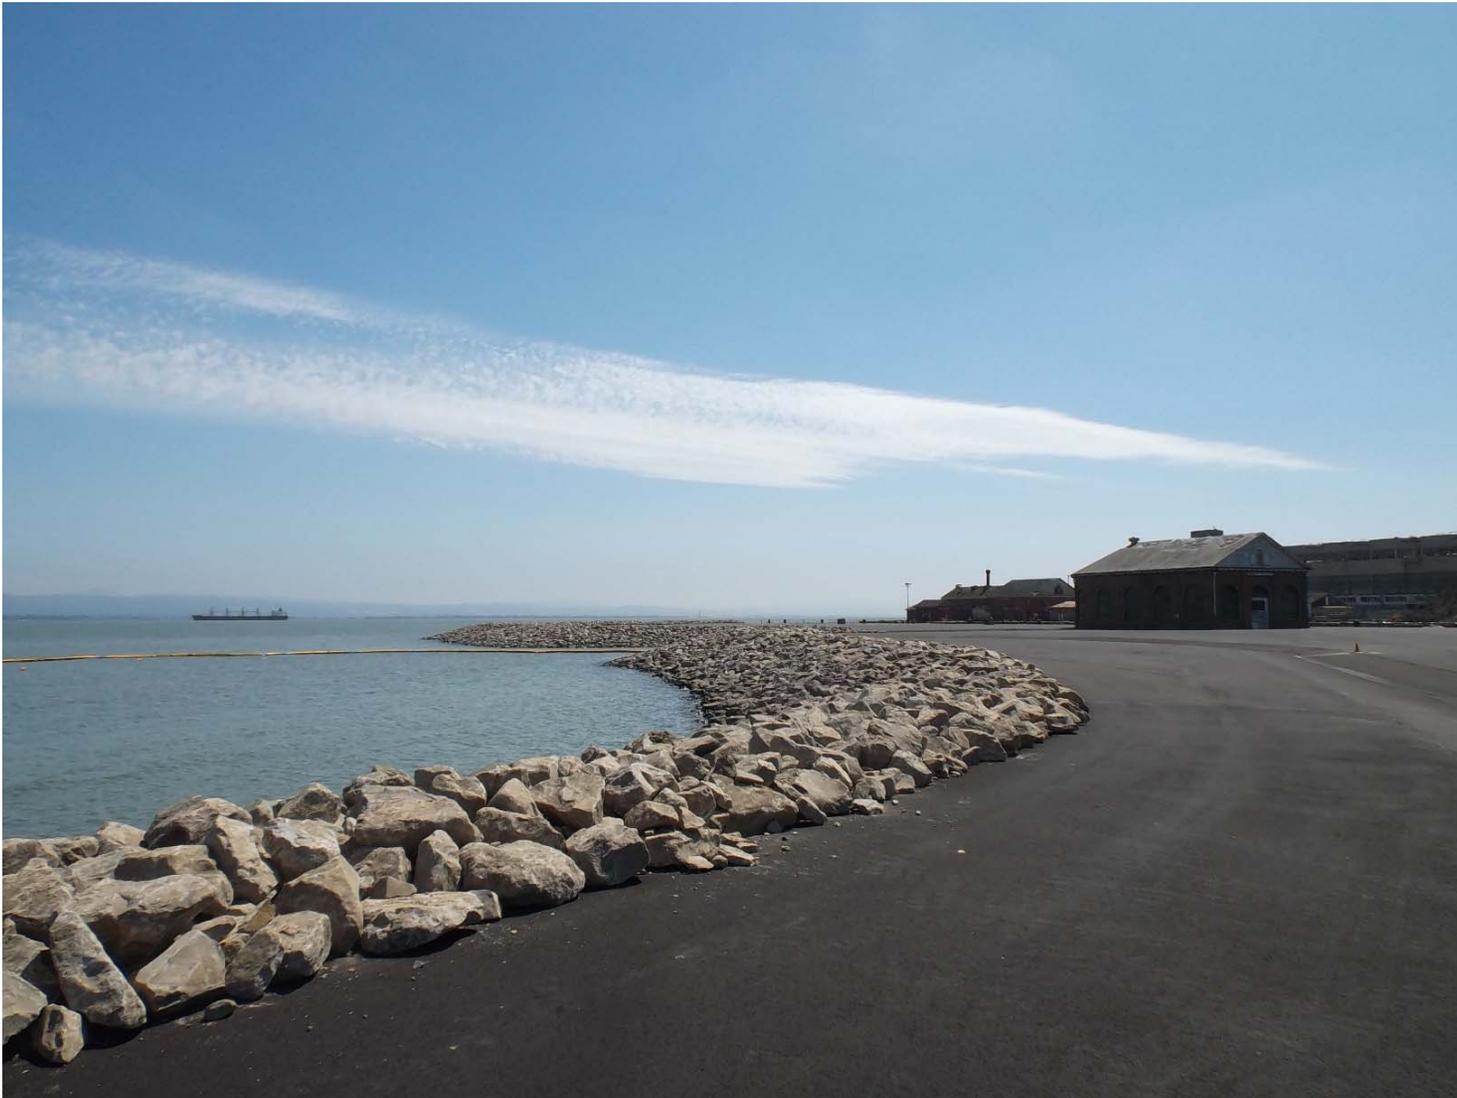
Revetment Crest Completed to Tie Into Asphalt Cover

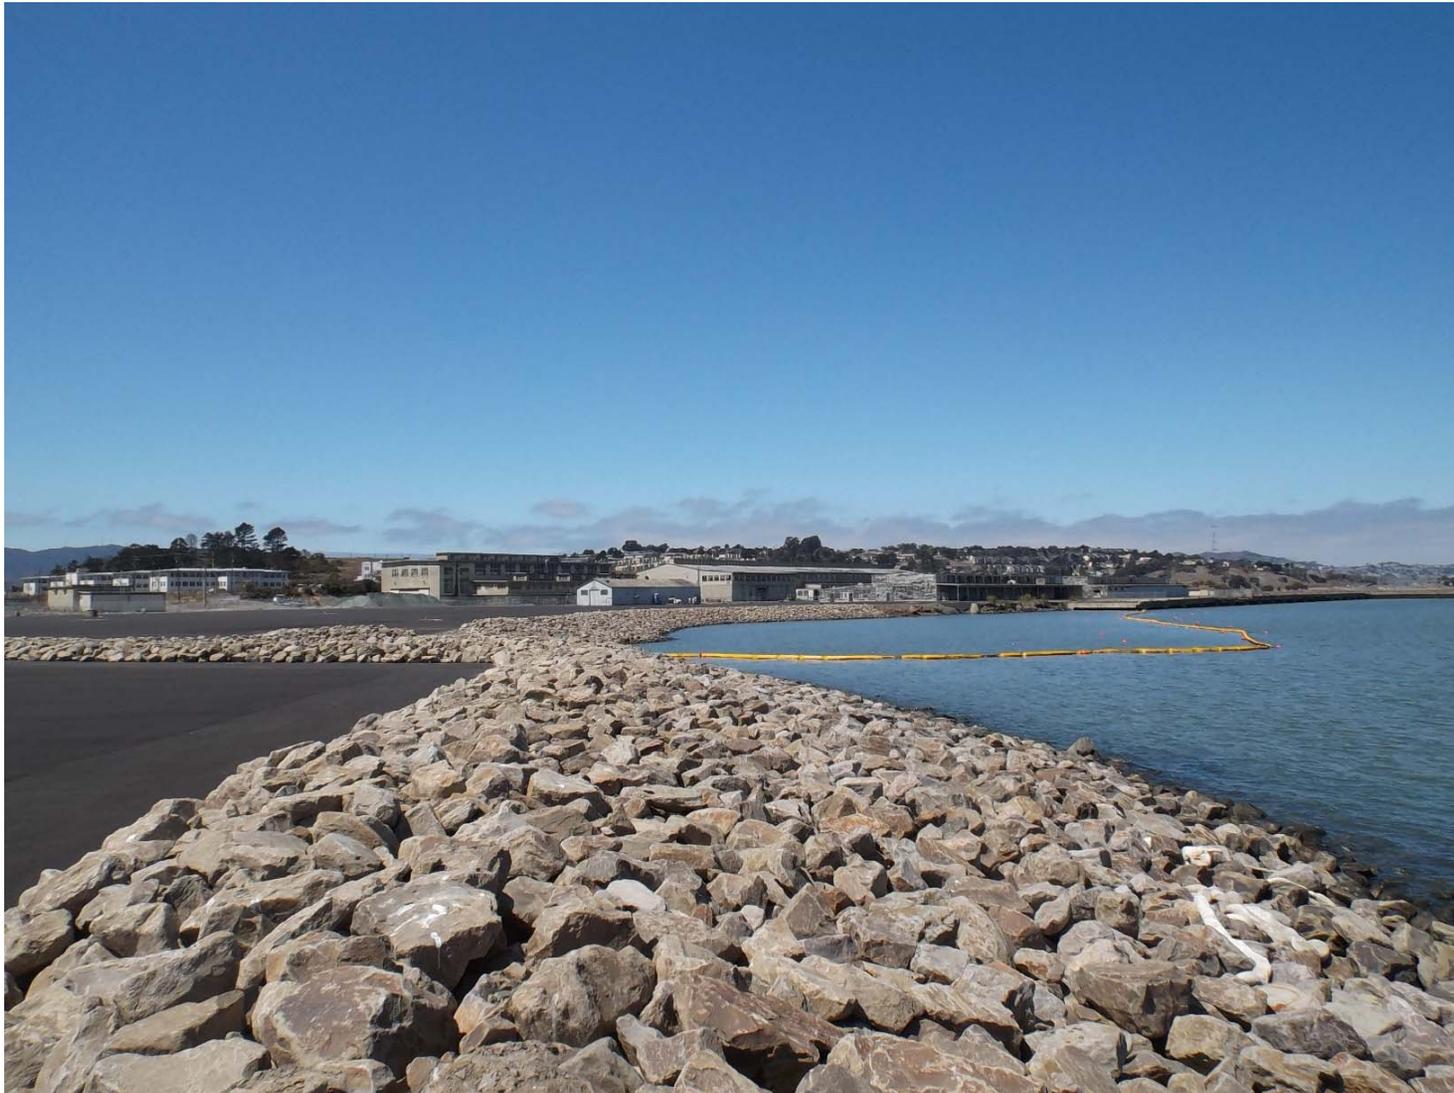
Revetment Crest Completed to Tie Into Asphalt Cover
